# Louisiana chemical plant minimizes production losses using patented deposit sensor technology to identify and proactively address biofilm deposition

## CASE STUDY

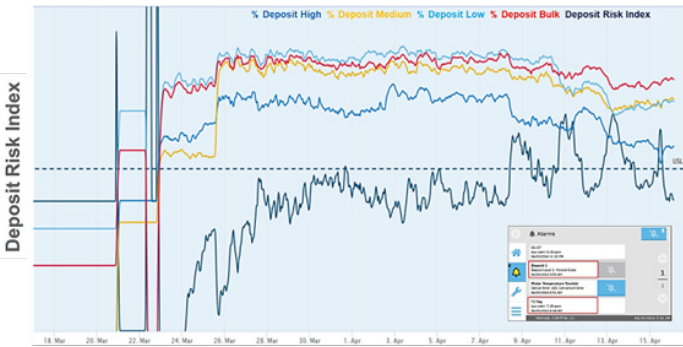
**FIGURE 1:** Increased deposit risk index and alarm from Premium Plus indicating mineral scale event with low severity.

sensor detected two major deposit events. The first event, based on the alarm from the sensor, was identified as mineral scale (figure 1). A corrective slug dose of scale dispersant was administered by Nalco Water's onsite expert which effectively recovered the system to its original state (figure 2).

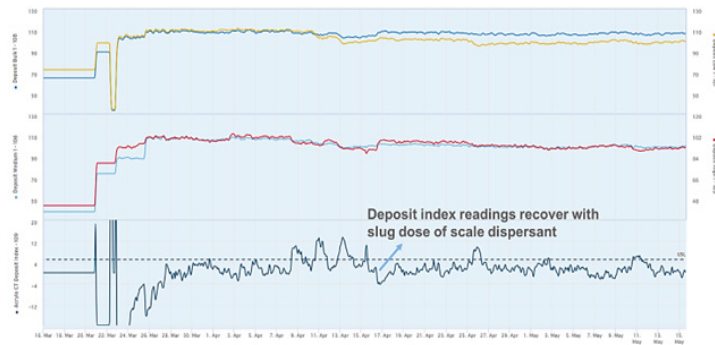
**FIGURE 2:** Deposit risk index readings recover with slug dose of scale dispersant.

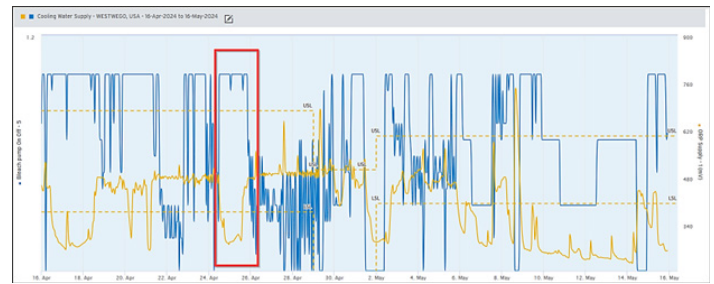
**FIGURE 4:** On 24-25 April, oxidation-reduction potential (ORP) declined, but the bleach pump relay indicated the pump was running. However, the bleach pump had failed. Once the pump was repaired, ORP increased and the deposit risk index declined, indicating a clean-up of the biofilm.

Premium Plus detected a second event which the sensor identified as biofilm deposition (figure 3). Nalco Water's EGIC team investigated further and identified the root cause to be a discrepancy in bleach feed (figure 4). Nalco Water representatives worked closely with the customer to implement bleach feed changes to return the system to normal.

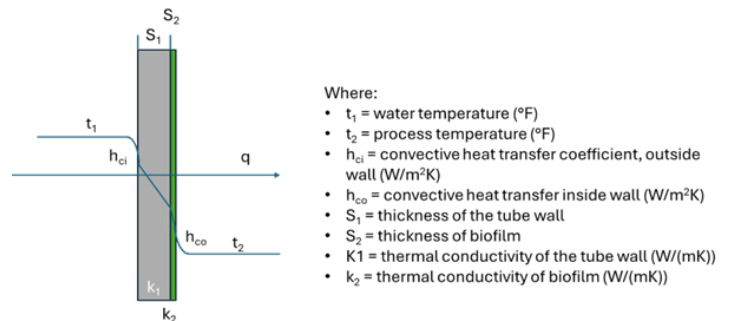
**FIGURE 5:** Biofilm conducts heat 625X less readily than a copper heat exchanger tube. Even a very thin layer of biofilm retards heat transfer enough to affect production rates. In this case, the biofilm layer was estimated to be only 20 microns thick, about the width of a human hair, with an estimated \$700,000 in lost production.
