Bleached Kraft Pulp Mill Saves \$5/Ton in Bleaching Chemicals Through SCALE-GUARD™ PLUS Technology

Mill Overview

Mill:	Integrated Kraft Pulp Mill
Grade:	Market Pulp, Uncoated Free Sheet
Equipment:	3 Stage Bleach Plant - D100, Ep, D1 Kamyrgester
Production:	1,050 BD TPD
Species:	Bleached Hardwood

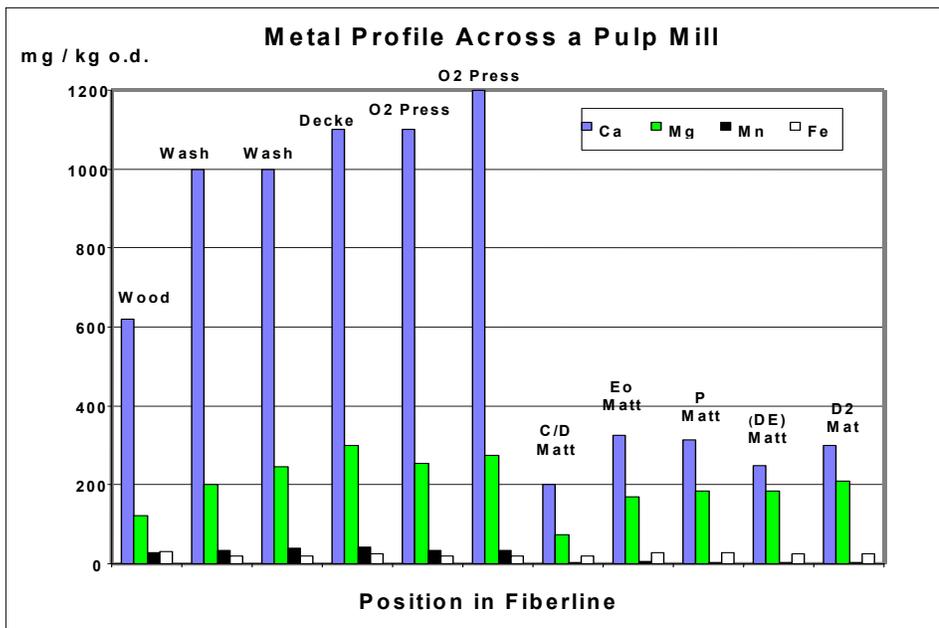
Figure 1 - Typical metals profile of a modern pulp mill. Taken from: "Metals Management in the Fiberline", Patrick S. Bryant.

Management of inorganic contaminants begins at the digester and plays a critical role in controlling the problems such contaminants can create throughout the pulp mill. Water optimization and process changes can result in the accumulation of tenacious scale deposits in critical areas. In addition, many pulp mills have modified their washing and bleaching processes due to changing environmental regulations. All of these changes have created an ideal environment for increased scaling problems, reduced brightness ceilings, escalating energy costs, imbalances in organic levels and increased operating costs. Figure 1 depicts a typical metals profile of a modern pulp mill.

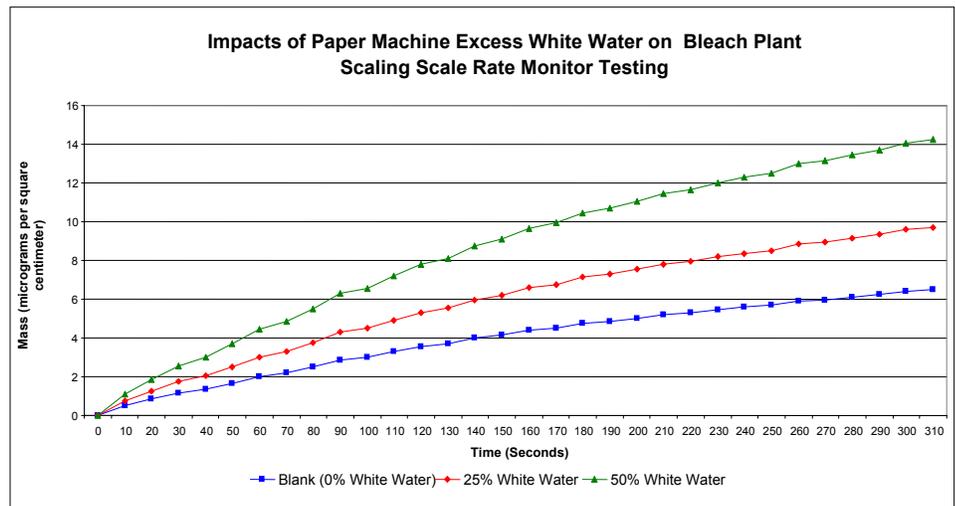
Figure 2 - Impact of Paper Machine White Water on Bleach Plant Scaling with Scale Rate Monitor.

The mill had the capability to utilize every ton of pulp that can be produced, either as paper machine production or market pulp. To help reduce fresh water consumption, the bleach plant was mandated to utilize carbonate-filled paper machine white water as shower water on the D100 washer. This caused significant scaling in the E_p stage, resulting in the loss of 460 tons of bleached pulp production every 6 weeks.
